**Flood Control Project Maintenance  
Levee Inspections**

**Fall 2009 Levee Maintenance Deficiency Summary Report**

**Levee Inspection Report By Mile - Fall 2009**

**City of Sacramento**

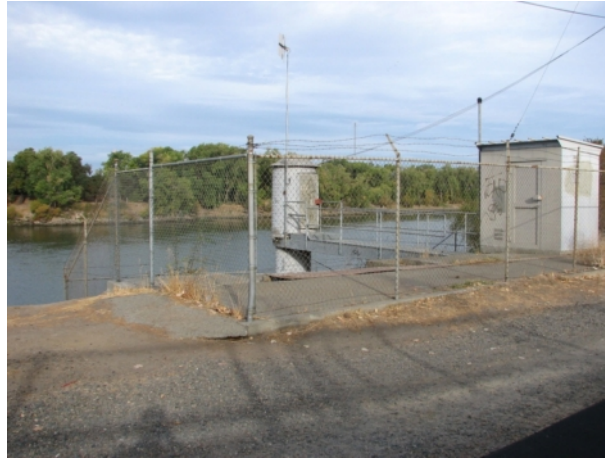
john\_gw\_20090924\_3.jpg

Recorder can (DWR)

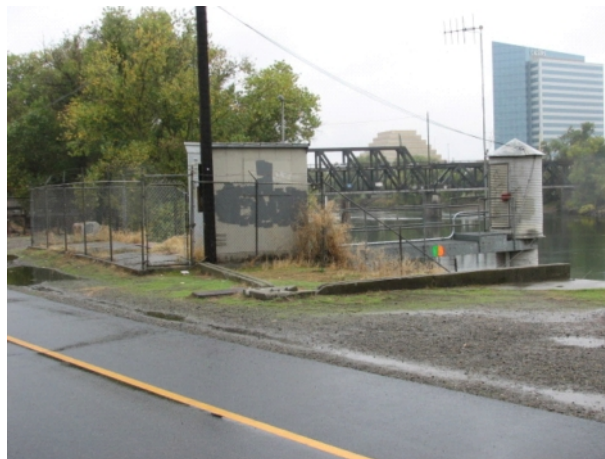
john\_gw\_20091019\_39.jpg

1st recorder can

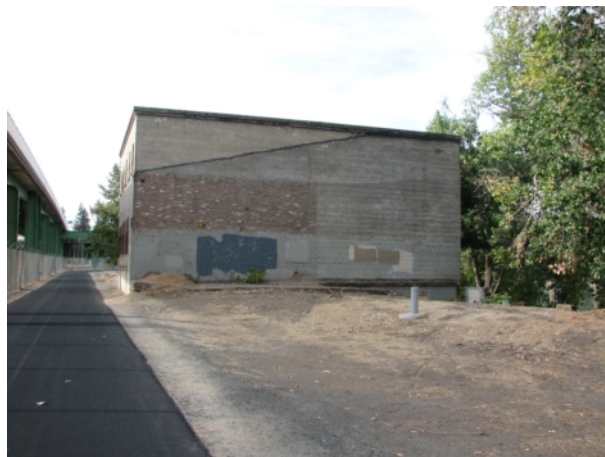
john\_gw\_20090924\_4.jpg

Historical Building : State Parks &amp; Recreations

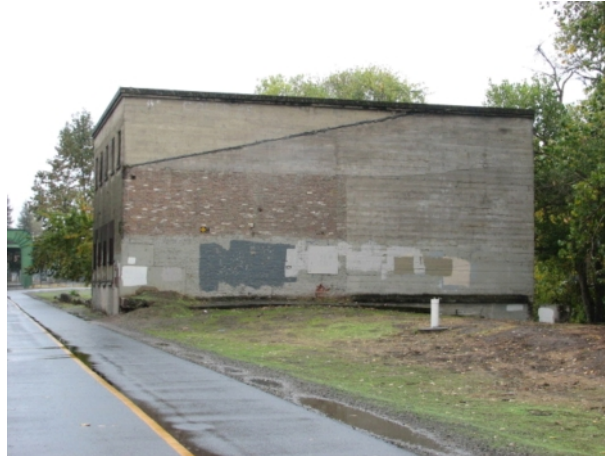
Levee Mile Report Line	2
Start Levee Mile	0.16
End Levee Mile	0.16
Location	Water Side
Category	Earthen Levee
Item	Encroachments
Historical Building with foundations and Ramps on upstream and downstream sides	
johnngw_20091019_40.jpg

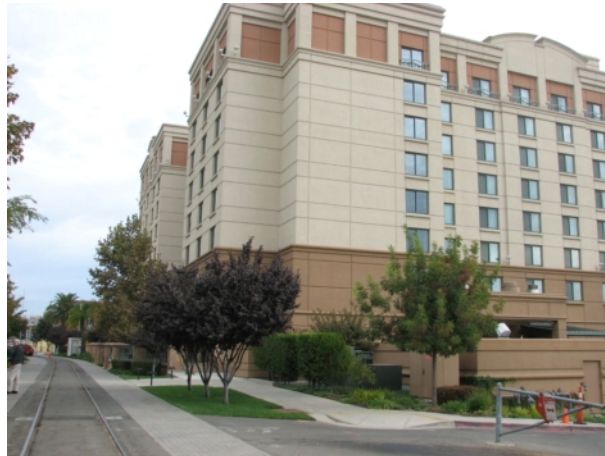
Levee Mile Report Line	3
Start Levee Mile	0.78
End Levee Mile	0.78
Location	Crown
Category	Earthen Levee
Item	Encroachments
Embassy Suites	
johnngw_20090924_5.jpg

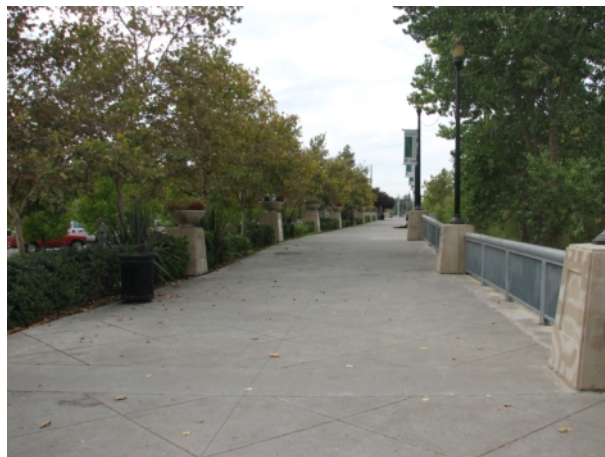
Levee Mile Report Line	4
Start Levee Mile	0.78
End Levee Mile	0.93
Location	Crown
Category	Earthen Levee
Item	Encroachments
River walk crown with landscaping	
johnngw_20090924_6.jpg

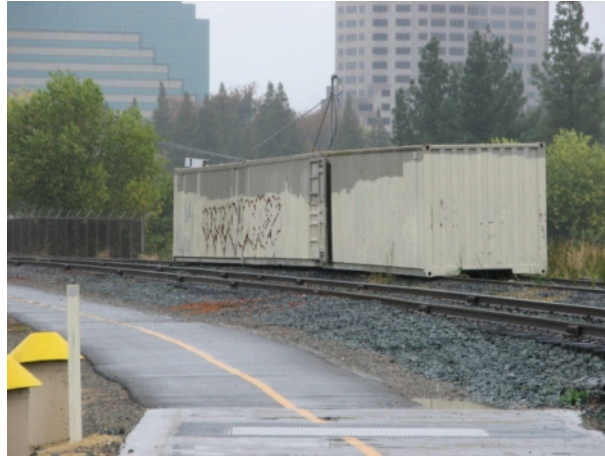
Levee Mile Report Line	5
Start Levee Mile	1.52
End Levee Mile	1.52
Location	Crown
Category	Earthen Levee
Item	Encroachments
Storage bins on tracks placed by Railroad Museum	
johnngw_20091019_41.jpg

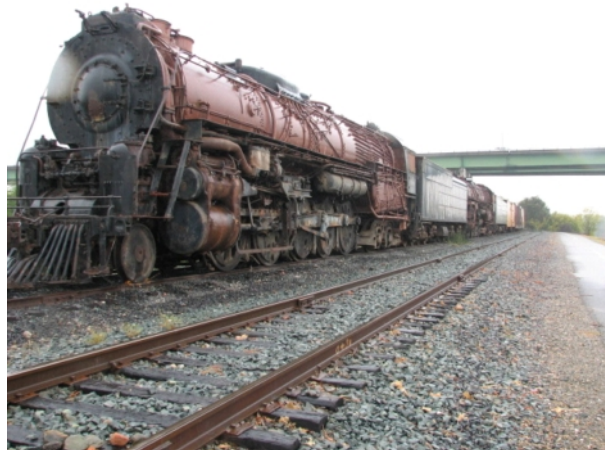
5	1.52	1.52	Earthen Levee	Encroachments	CR	PO	Buildings	38.572267 ° -121.512312 °	38.572267 ° -121.512312 °	11 Y
6	1.54	1.54	Earthen Levee	Encroachments	CR	M	Equipment Inspector Comments: This area is a concern due to work the COE did at Pioneer Reservoir with a stability berm and monitoring wells on the land side. This is due to the levee seepage. The concern is that the weight of the train cars may cause problems. Total eight cars.	38.571495 ° -121.513615 °	38.571495 ° -121.513615 °	12 Y
7	1.73	1.96	Earthen Levee	Encroachments	CR	PO	Equipment Inspector Comments: Levee is oversize with railroad tracks and paved parking this area is Miller Park	38.568172 ° -121.516042 °	38.564882 ° -121.516265 °	6 Y
8	1.96	2.34	Earthen Levee	Encroachments	CR	PO	Equipment Inspector Comments: Railroad tracks run on crown of levee, paved roadway runs along toe on waterside this is Miller Park Marina area.	38.564900 ° -121.516253 °	38.559460 ° -121.515085 °	7 Y

Levee Mile Report Line	6
Start Levee Mile	1.54
End Levee Mile	1.54
Location	Crown
Category	Earthen Levee
Item	Encroachments
Picture of most of the train cars City of Sacramento is concerned about the weight of the cars on the levee This area has a seepage problem	
johnngw_20091019_42.jpg

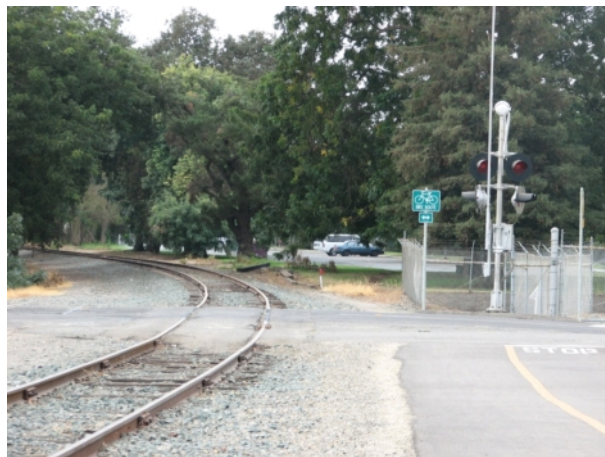
Levee Mile Report Line	7
Start Levee Mile	1.73
End Levee Mile	1.96
Location	Crown
Category	Earthen Levee
Item	Encroachments
Miller Park at Broadway rail road track and parking area on levee	
johnngw_20090924_7.jpg

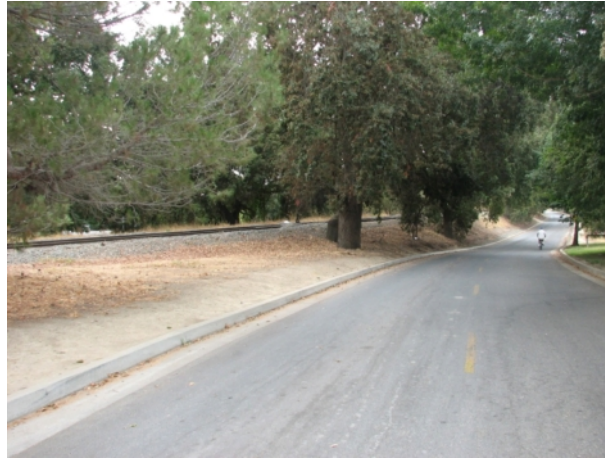
Levee Mile Report Line	8
Start Levee Mile	1.96
End Levee Mile	2.34
Location	Crown
Category	Earthen Levee
Item	Encroachments
Rail road tracks on levee crown street to boat ramp	
johnngw_20090924_8.jpg

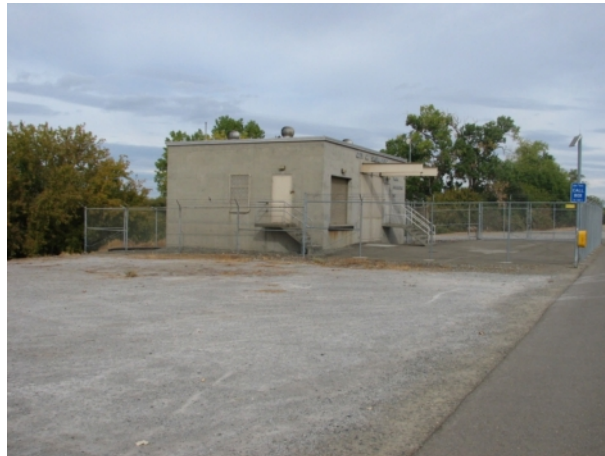
Levee Mile Report Line	10
Start Levee Mile	2.90
End Levee Mile	2.90
Location	Crown
Category	Earthen Levee
Item	Encroachments
pump station city of Sacramento crown of levee waterside	
johnngw_20090924_9.jpg
